# Alunorte

15 March, 2018

# More than 200 mm of rainfall in 12 hours (16-17 February)

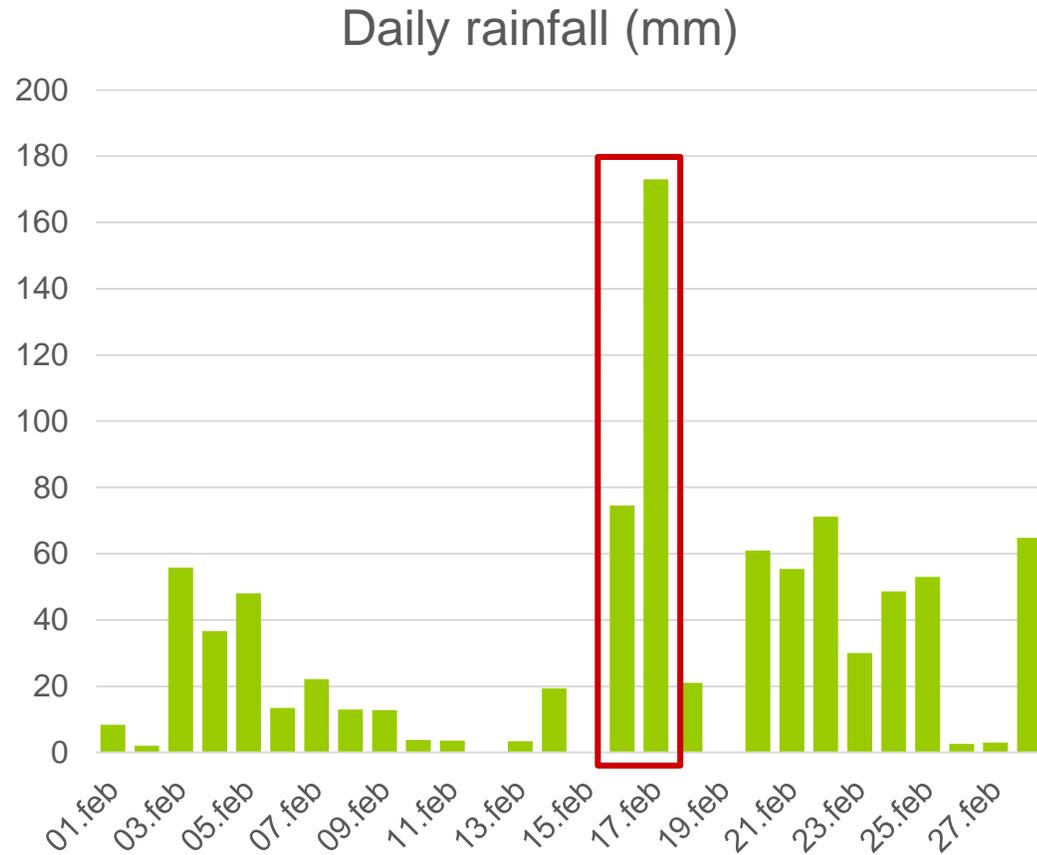
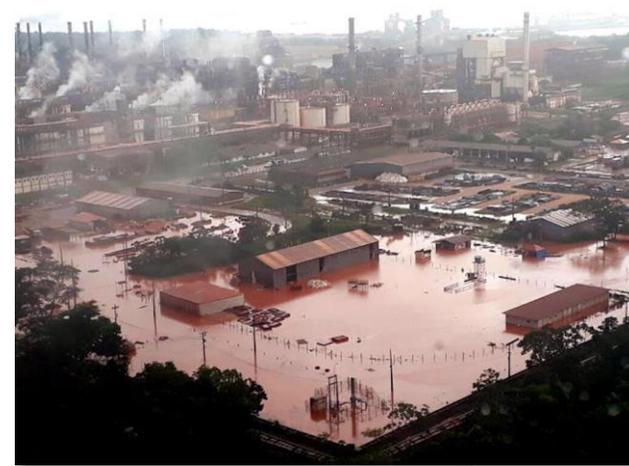
*The industrial premises inside Alunorte after the heavy rain fall, followed by extensive external inspections*

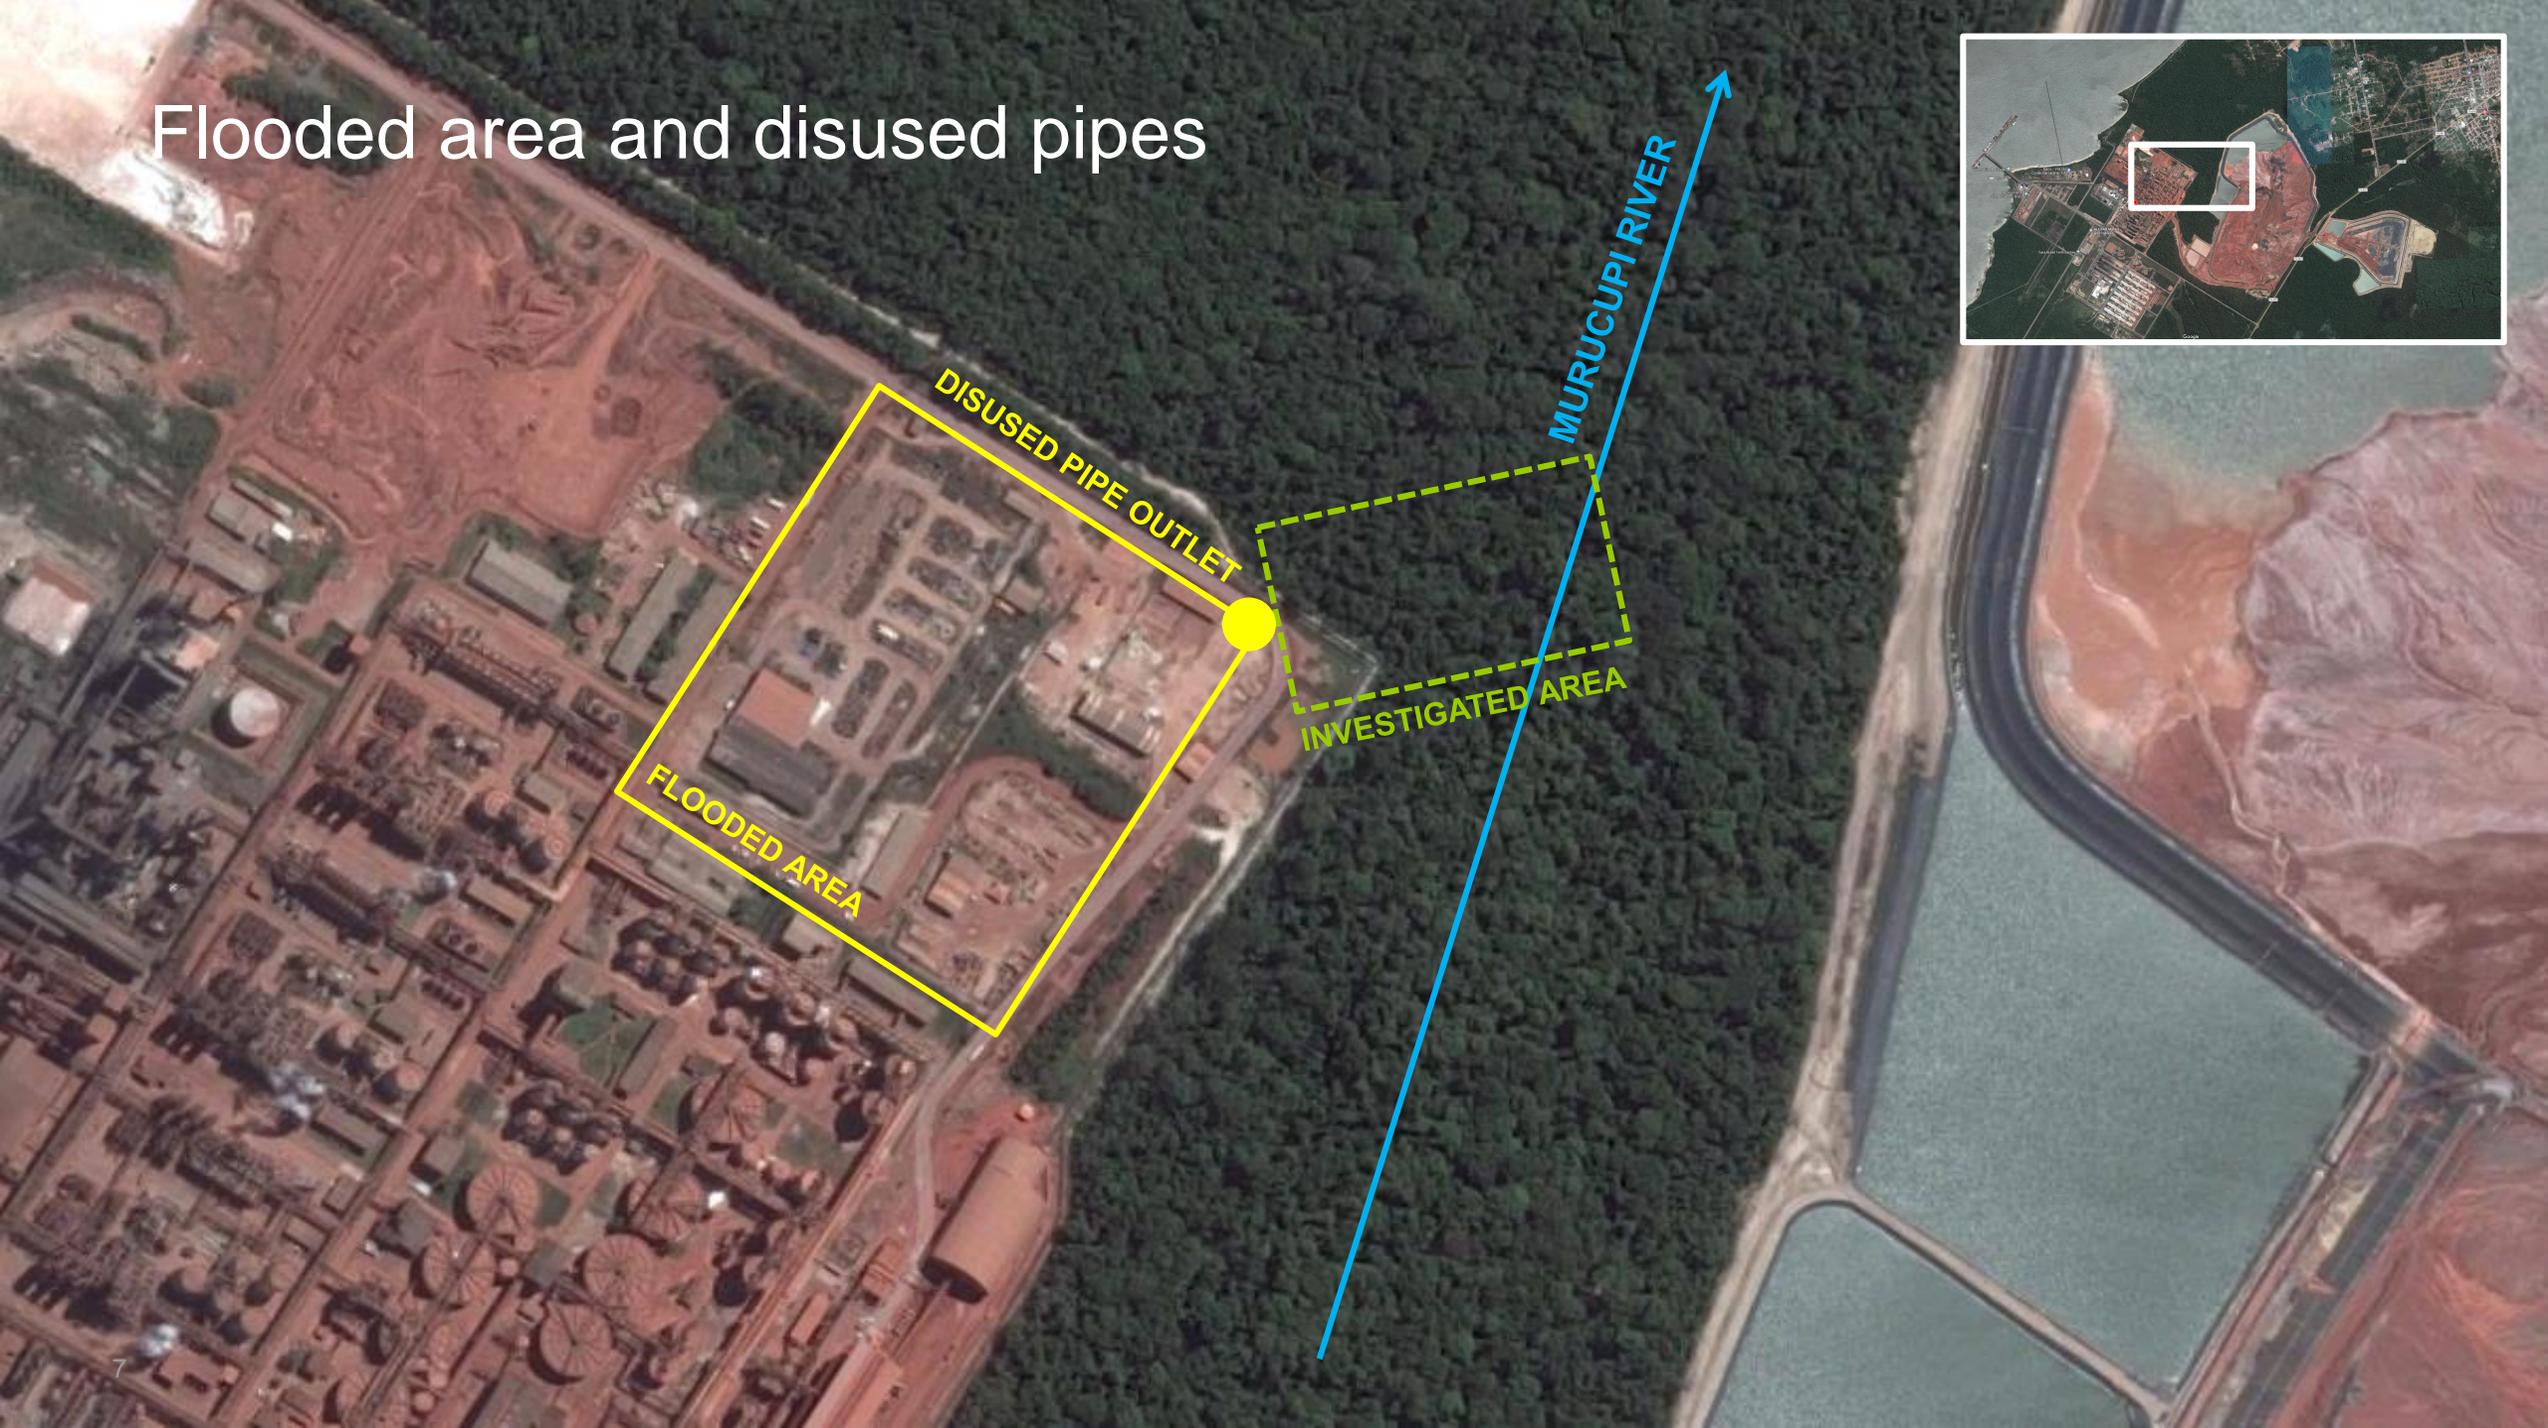
# Flooded area and disused pipes

DISUSED PIPE OUTLET

FLOODED AREA

INVESTIGATED AREA

#	Where	What	Leakage	Content	Consequences
1	<b>Bauxite residue deposits (DRS1 and DRS2)</b>		No indications of leakage or spill		
2	<b>Flooded area (Sump 45) and disused pipes</b>	Broken sealing in 1 of 5 pipes	Surface water that went above normal levels in Sump 45	Surface water	No significant environmental impact from a pH perspective within sampled area
3	<b>Canal Velho (outside lisenca)</b>	Discharge of partly untreated rainwater	Surface water and process water.  Power outage in the refinery caused a spill of process liquor with high caustic soda concentration that mixed with the surface water	Dust of bauxite, dust of mineral coal and process water with high caustic soda content that was naturally thinned by the large amounts of surface water	Increased levels of turbidity, at one measuring point above limit.  Basic pH monitoring over the relevant period indicates that, with the exceptions of a few spikes, the discharge to the river was within pH limits.

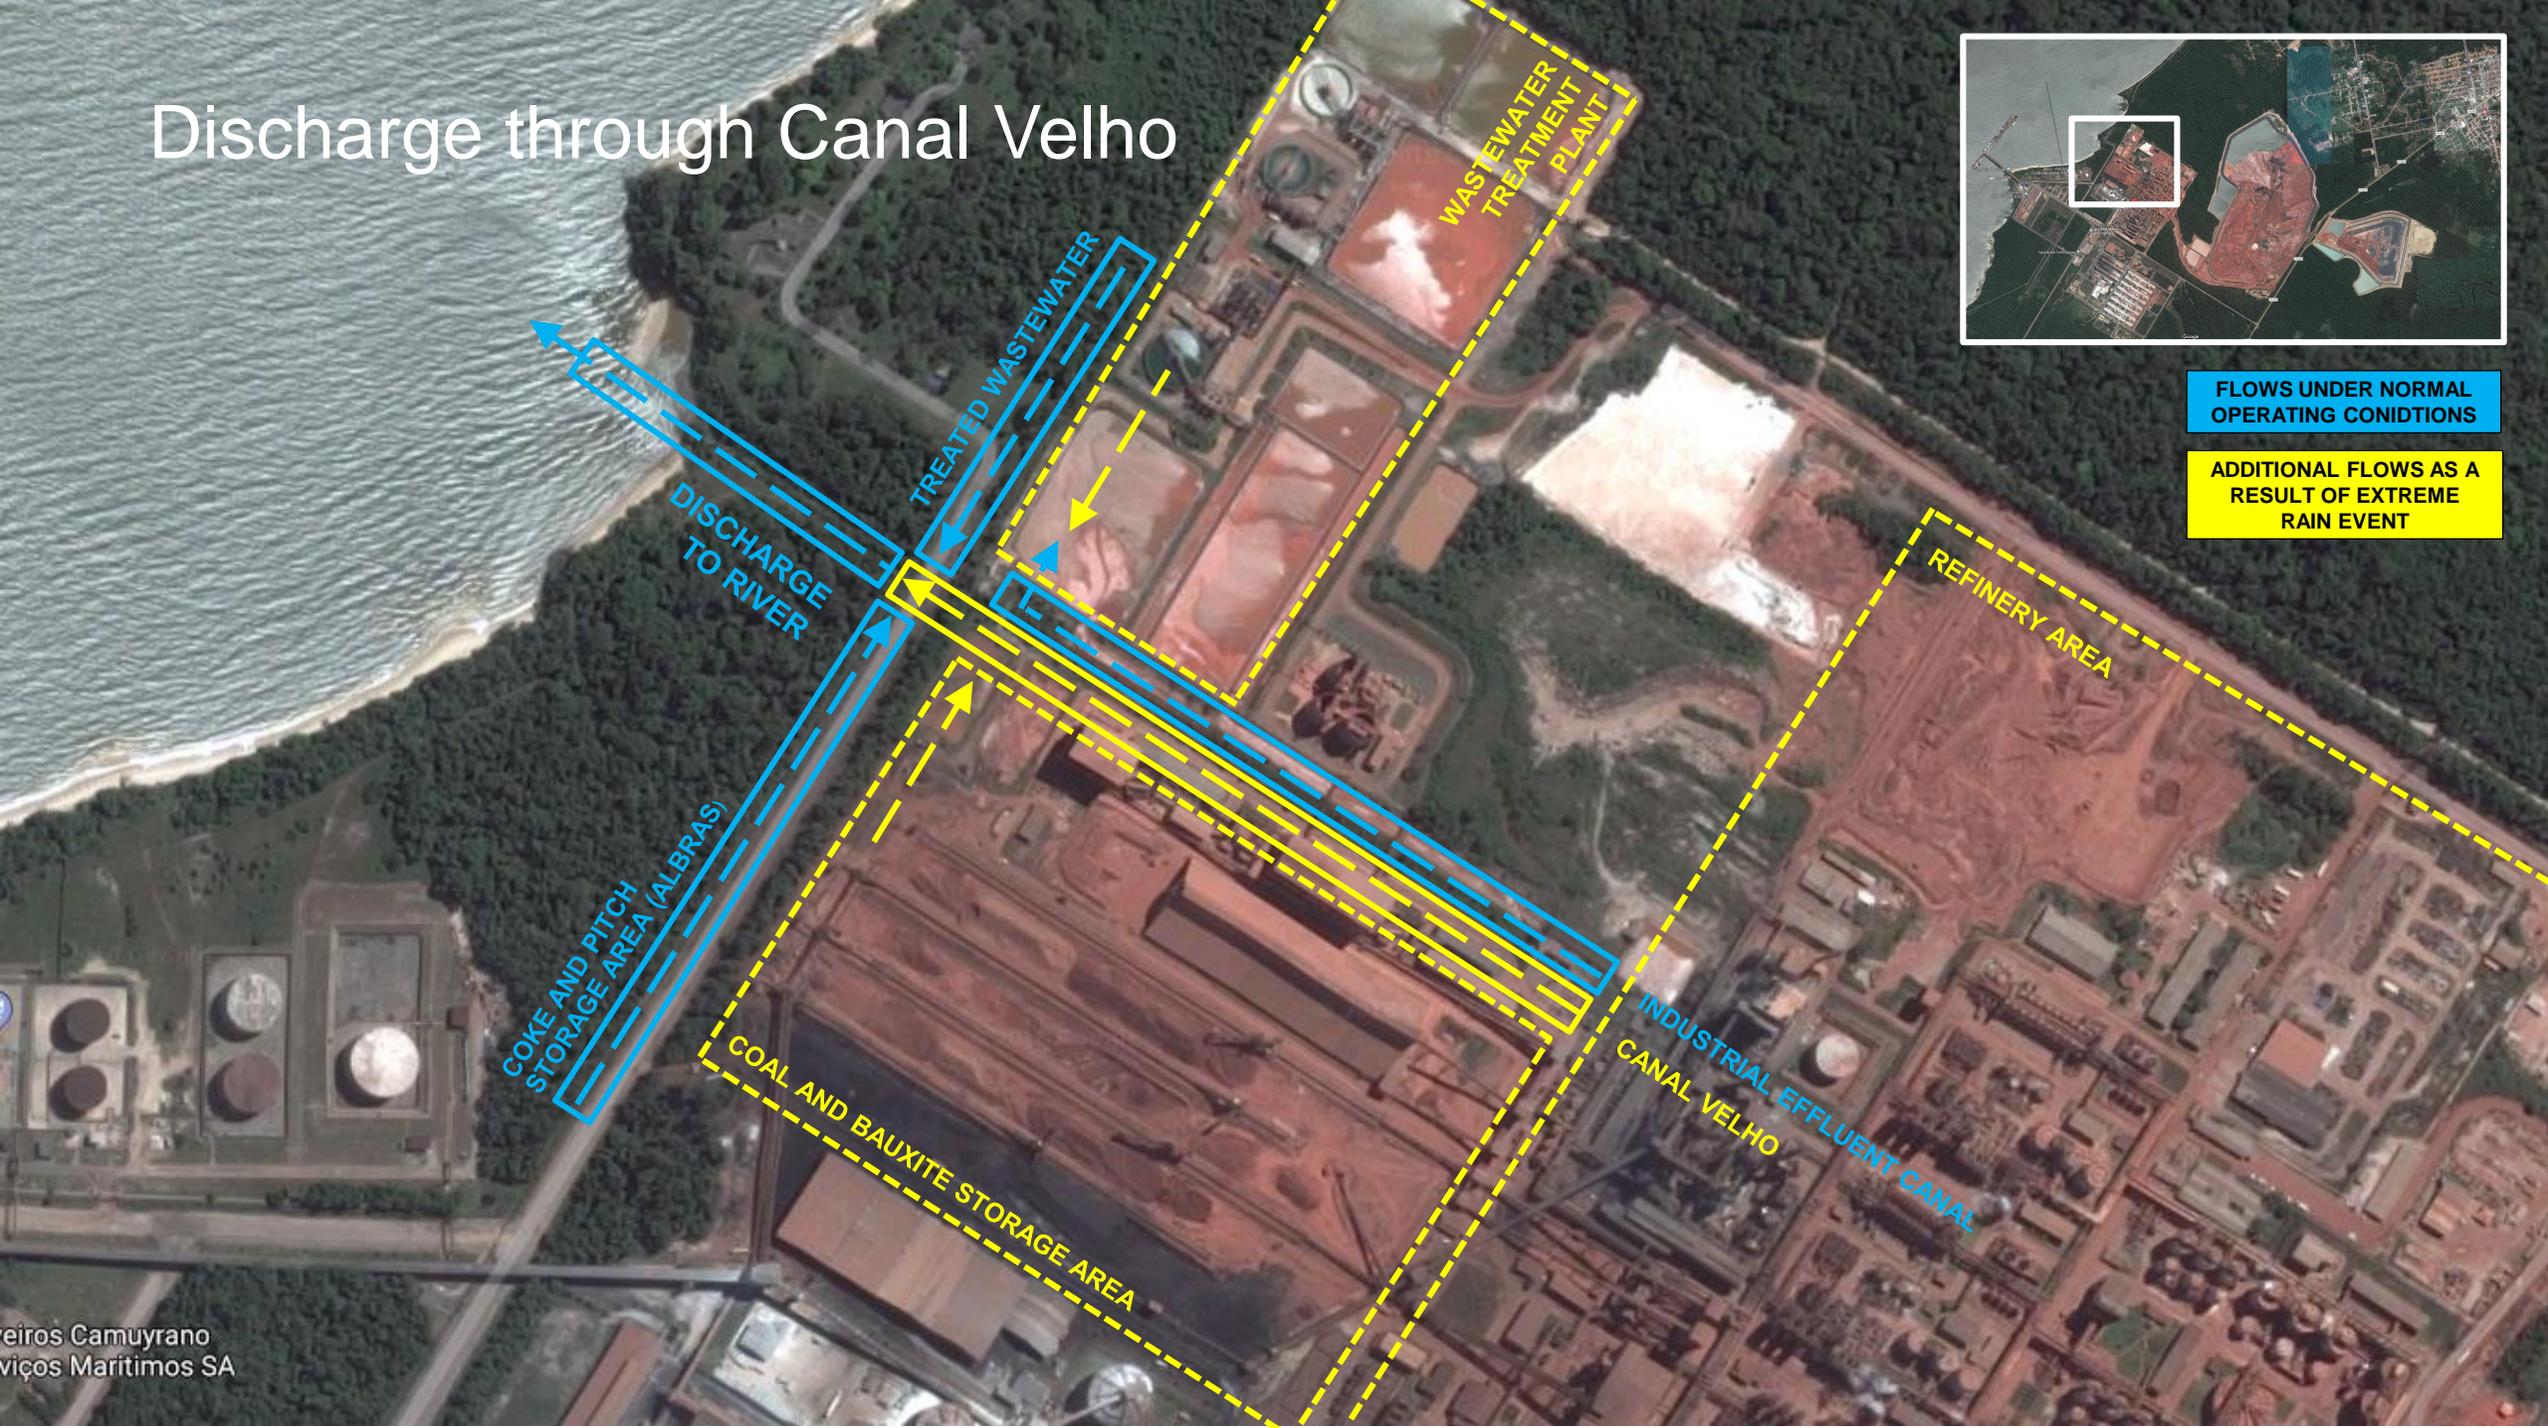
# Discharge through Canal Velho

INDUSTRIAL EFFLUENT CANAL CANAL VELHO

DISCHARGE TO RIVER

ADDITIONAL FLOWS AS A RESULT OF EXTREME RAIN EVENT
