➔ Review of Water and Effluent Management

Alunorte  
Barcarena/PA

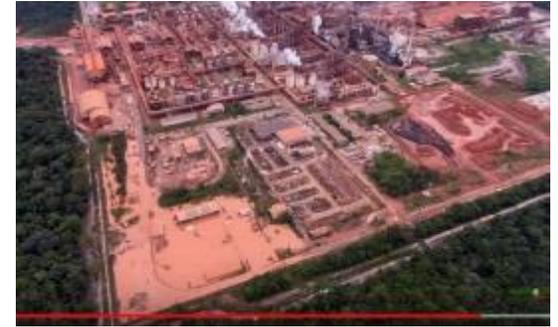
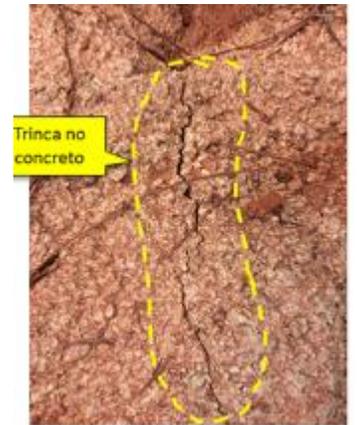
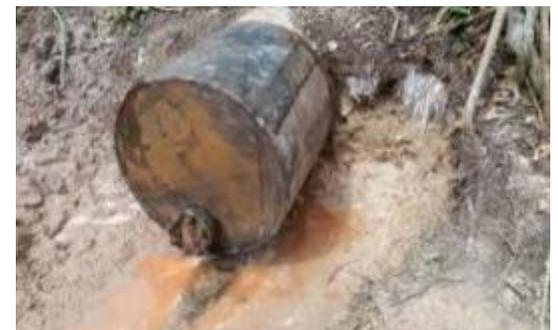
## 224mm rain in 10 hours

- ✓ There was no overflow at the solid waste basins - DRSs
- ✓ There was a Flood in Area 45 - The rainwater leakage occurred by a cracked deactivated pipe. Visual inspections and soil pH measurements results did not identify environmental alterations. **There was no overflow towards the Murucupi River. There are no evidences of environmental impacts in the river due to the deactivated pipe leakage.**
- ✓ Untreated rainwater was discharged into the **Pará River** by the *Canal Velho* in order to avoid WWTP basins overflowing. The discharge also received alkaline effluents from the process and there was a pH control and neutralization during this discharge.

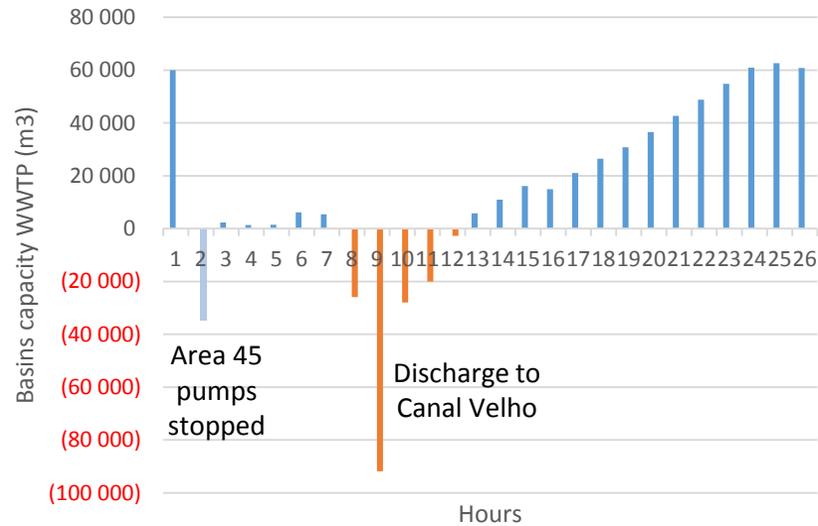
WWTP Basins Capacity

- ✓ WWTP basins volumes did not have capacity to handle the unusual rainfall event;
- ✓ DRSs capacities sufficient

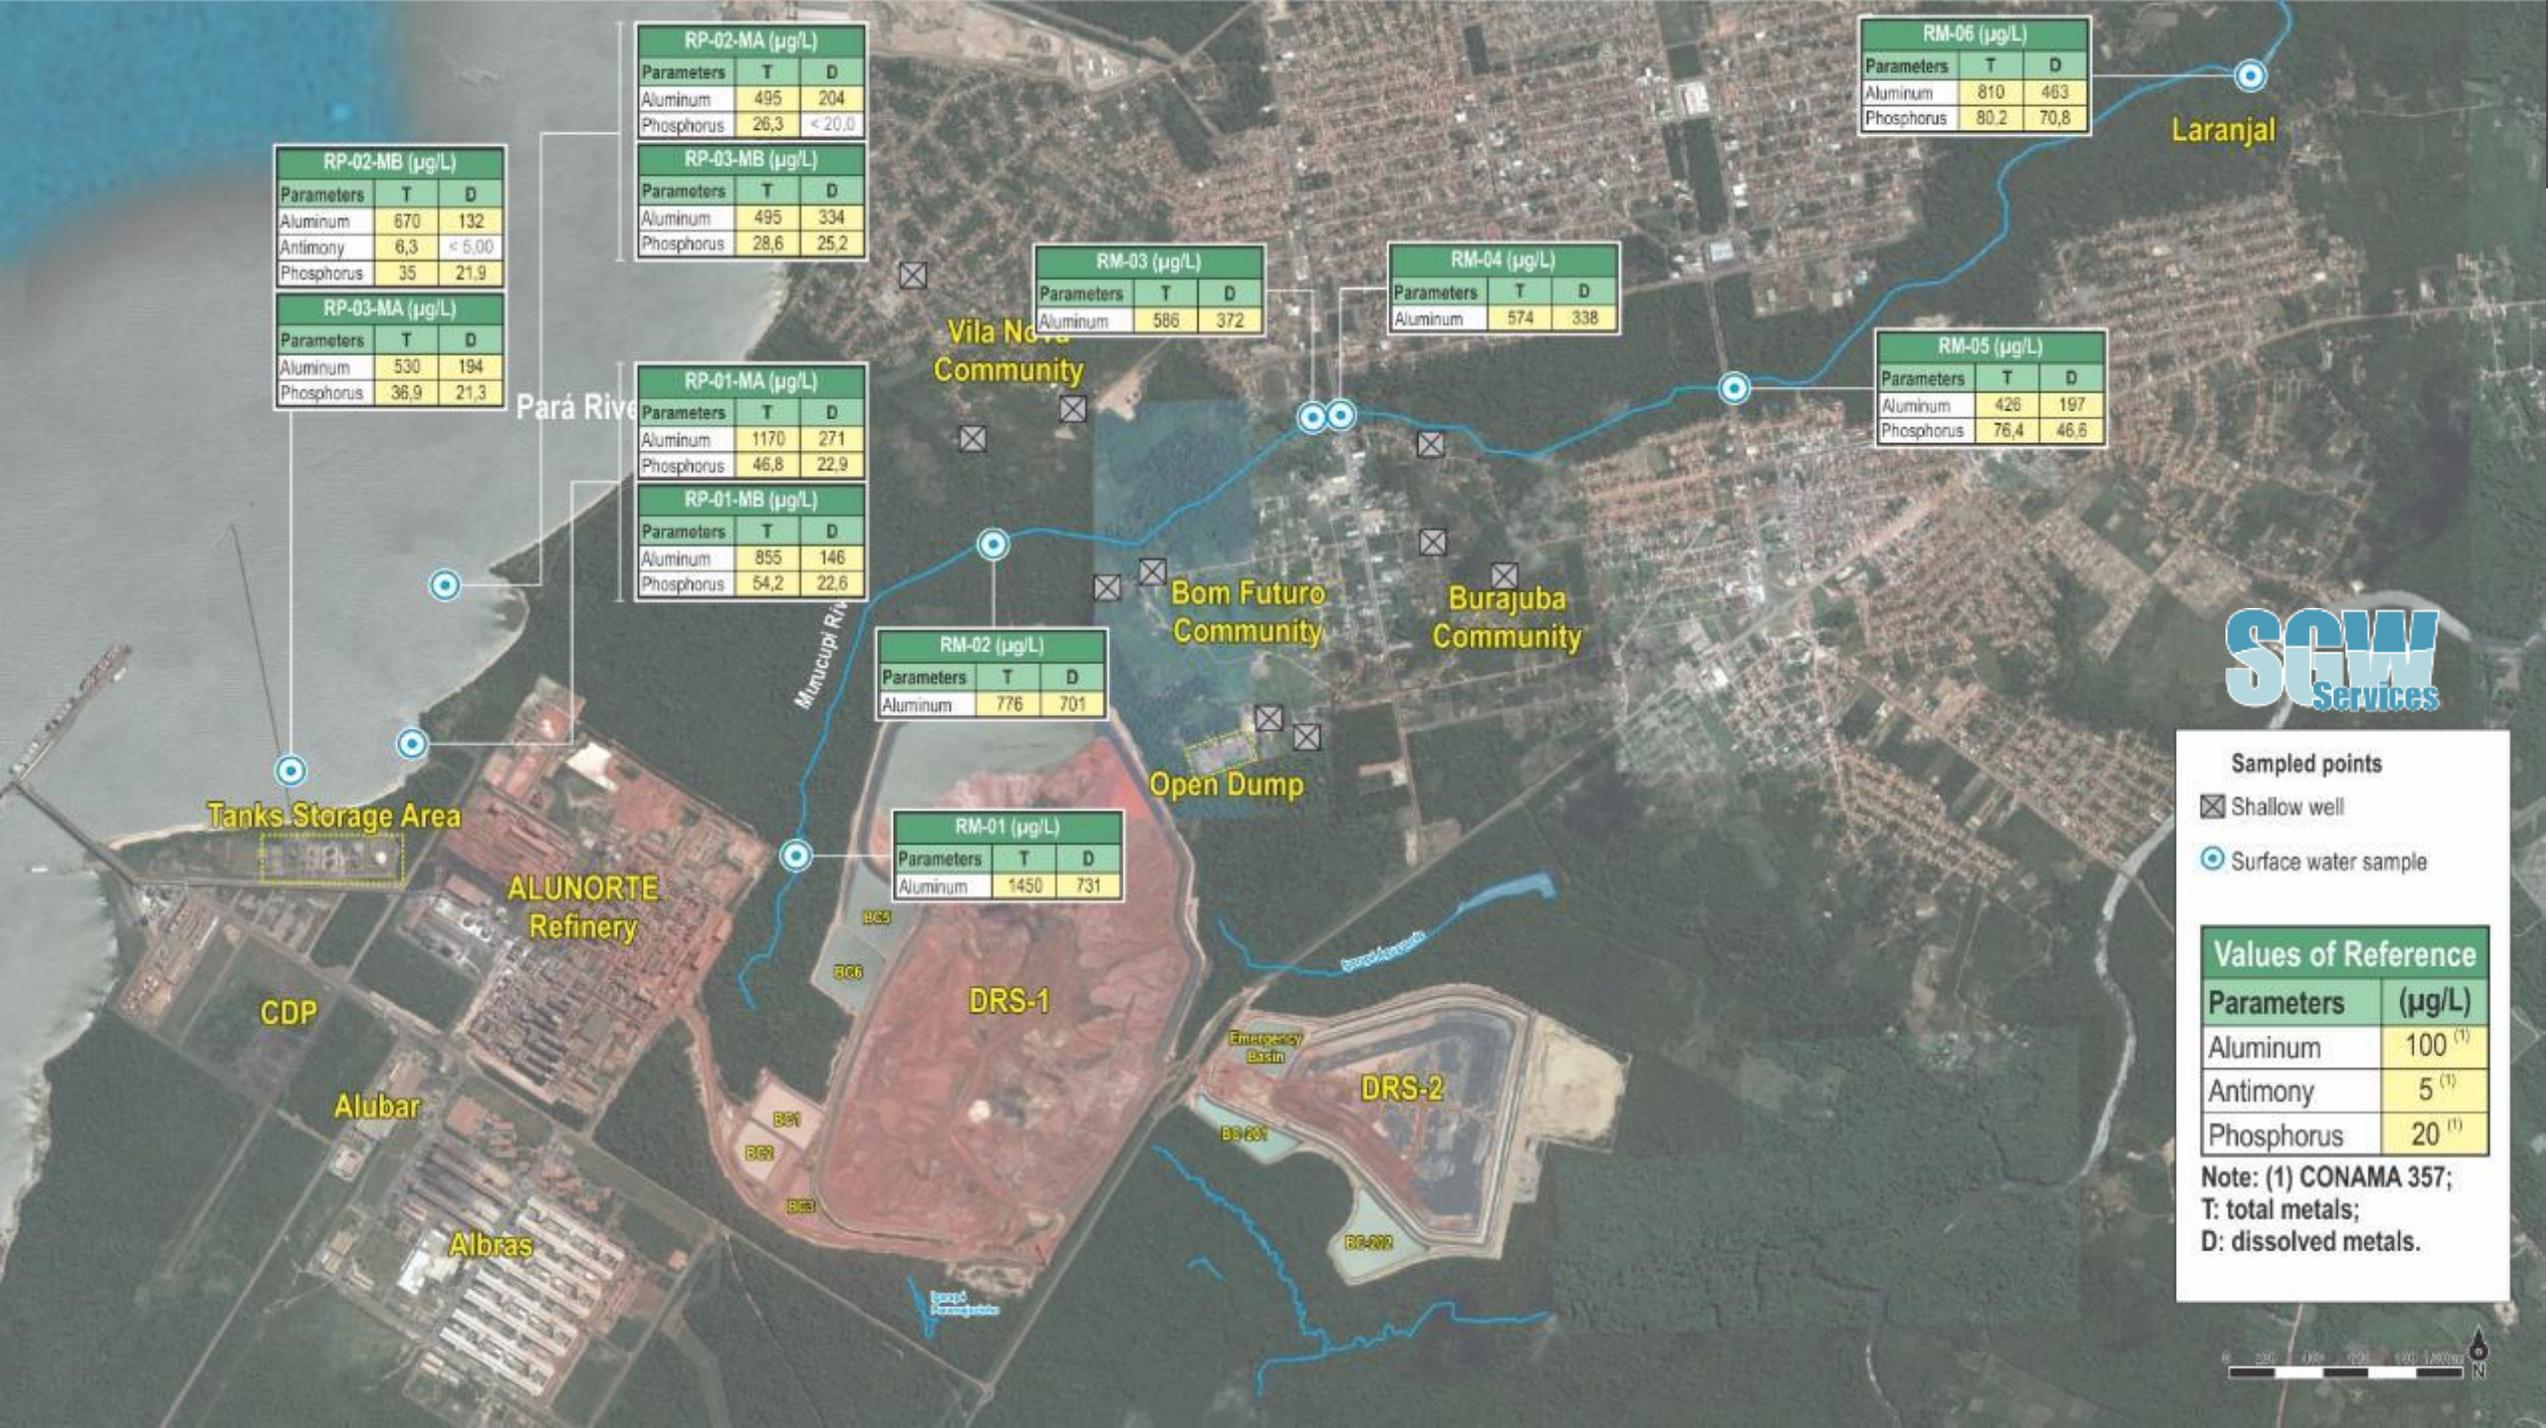
**Preliminary results indicate impact absence on water bodies and point to region's natural anomalies (Al and Fe)\***

RP-02-MB (µg/L)			
Parameters	T	D	
Aluminum	670	132	
Antimony	6,3	< 5,00	
Phosphorus	35	21,9

RP-03-MA (µg/L)			
Parameters	T	D	
Aluminum	530	194	
Phosphorus	36,9	21,3

RP-02-MA (µg/L)			
Parameters	T	D	
Aluminum	495	204	
Phosphorus	26,3	< 20,0

RP-03-MB (µg/L)			
Parameters	T	D	
Aluminum	495	334	
Phosphorus	28,6	25,2

RP-01-MA (µg/L)			
Parameters	T	D	
Aluminum	1170	271	
Phosphorus	46,8	22,9

RP-01-MB (µg/L)			
Parameters	T	D	
Aluminum	855	146	
Phosphorus	54,2	22,6

RM-02 (µg/L)			
Parameters	T	D	
Aluminum	776	701

RM-01 (µg/L)			
Parameters	T	D	
Aluminum	1450	731

RM-03 (µg/L)			
Parameters	T	D	
Aluminum	586	372

RM-04 (µg/L)			
Parameters	T	D	
Aluminum	574	338

RM-06 (µg/L)			
Parameters	T	D	
Aluminum	810	463	
Phosphorus	80,2	70,8

RM-05 (µg/L)			
Parameters	T	D	
Aluminum	426	197	
Phosphorus	76,4	46,6

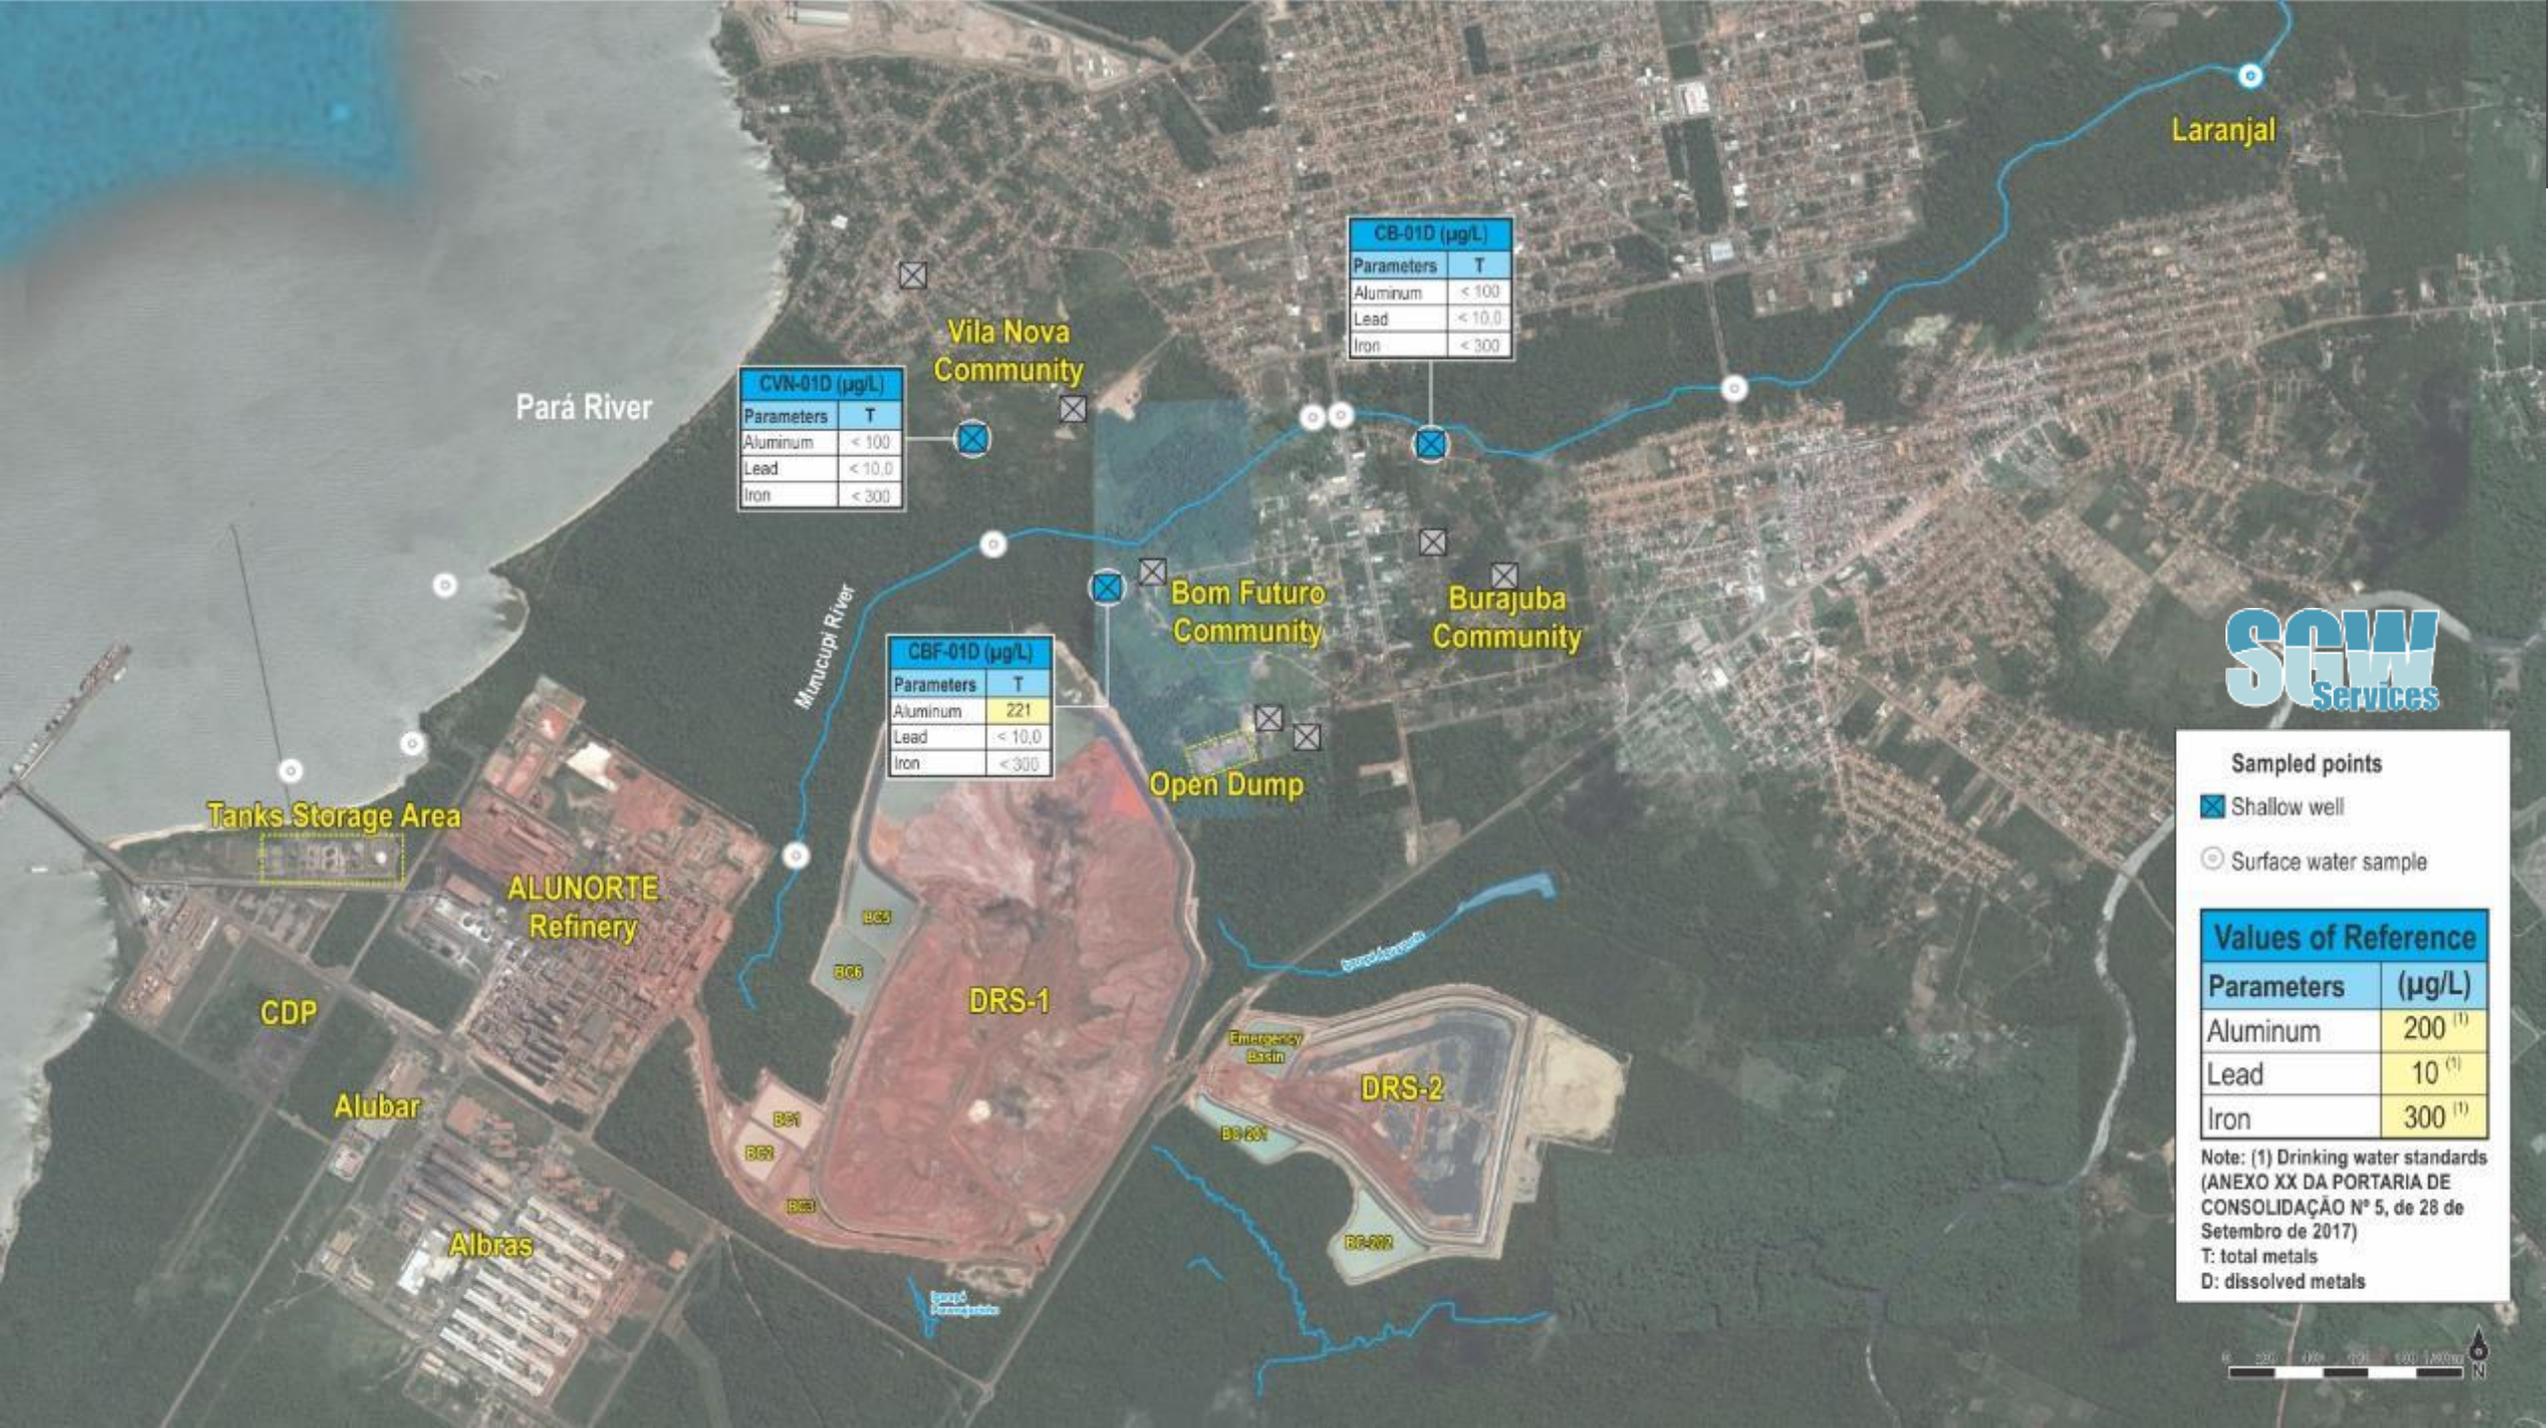
**The metals results are n/d or below the legal levels in the community wells - except 1 spot (Al = 220 ppb - Standard 200 ppb).**

**CVN-01D (µg/L)**

Parameters	T
Aluminum	< 100
Lead	< 10,0
Iron	< 300

**CB-01D (µg/L)**

**CBF-01D (µg/L)**

Parameters	T
Aluminum	221
Lead	< 10,0
Iron	< 300
