➔ Review of Water and Effluent Management

Alunorte  
Barcarena/PA

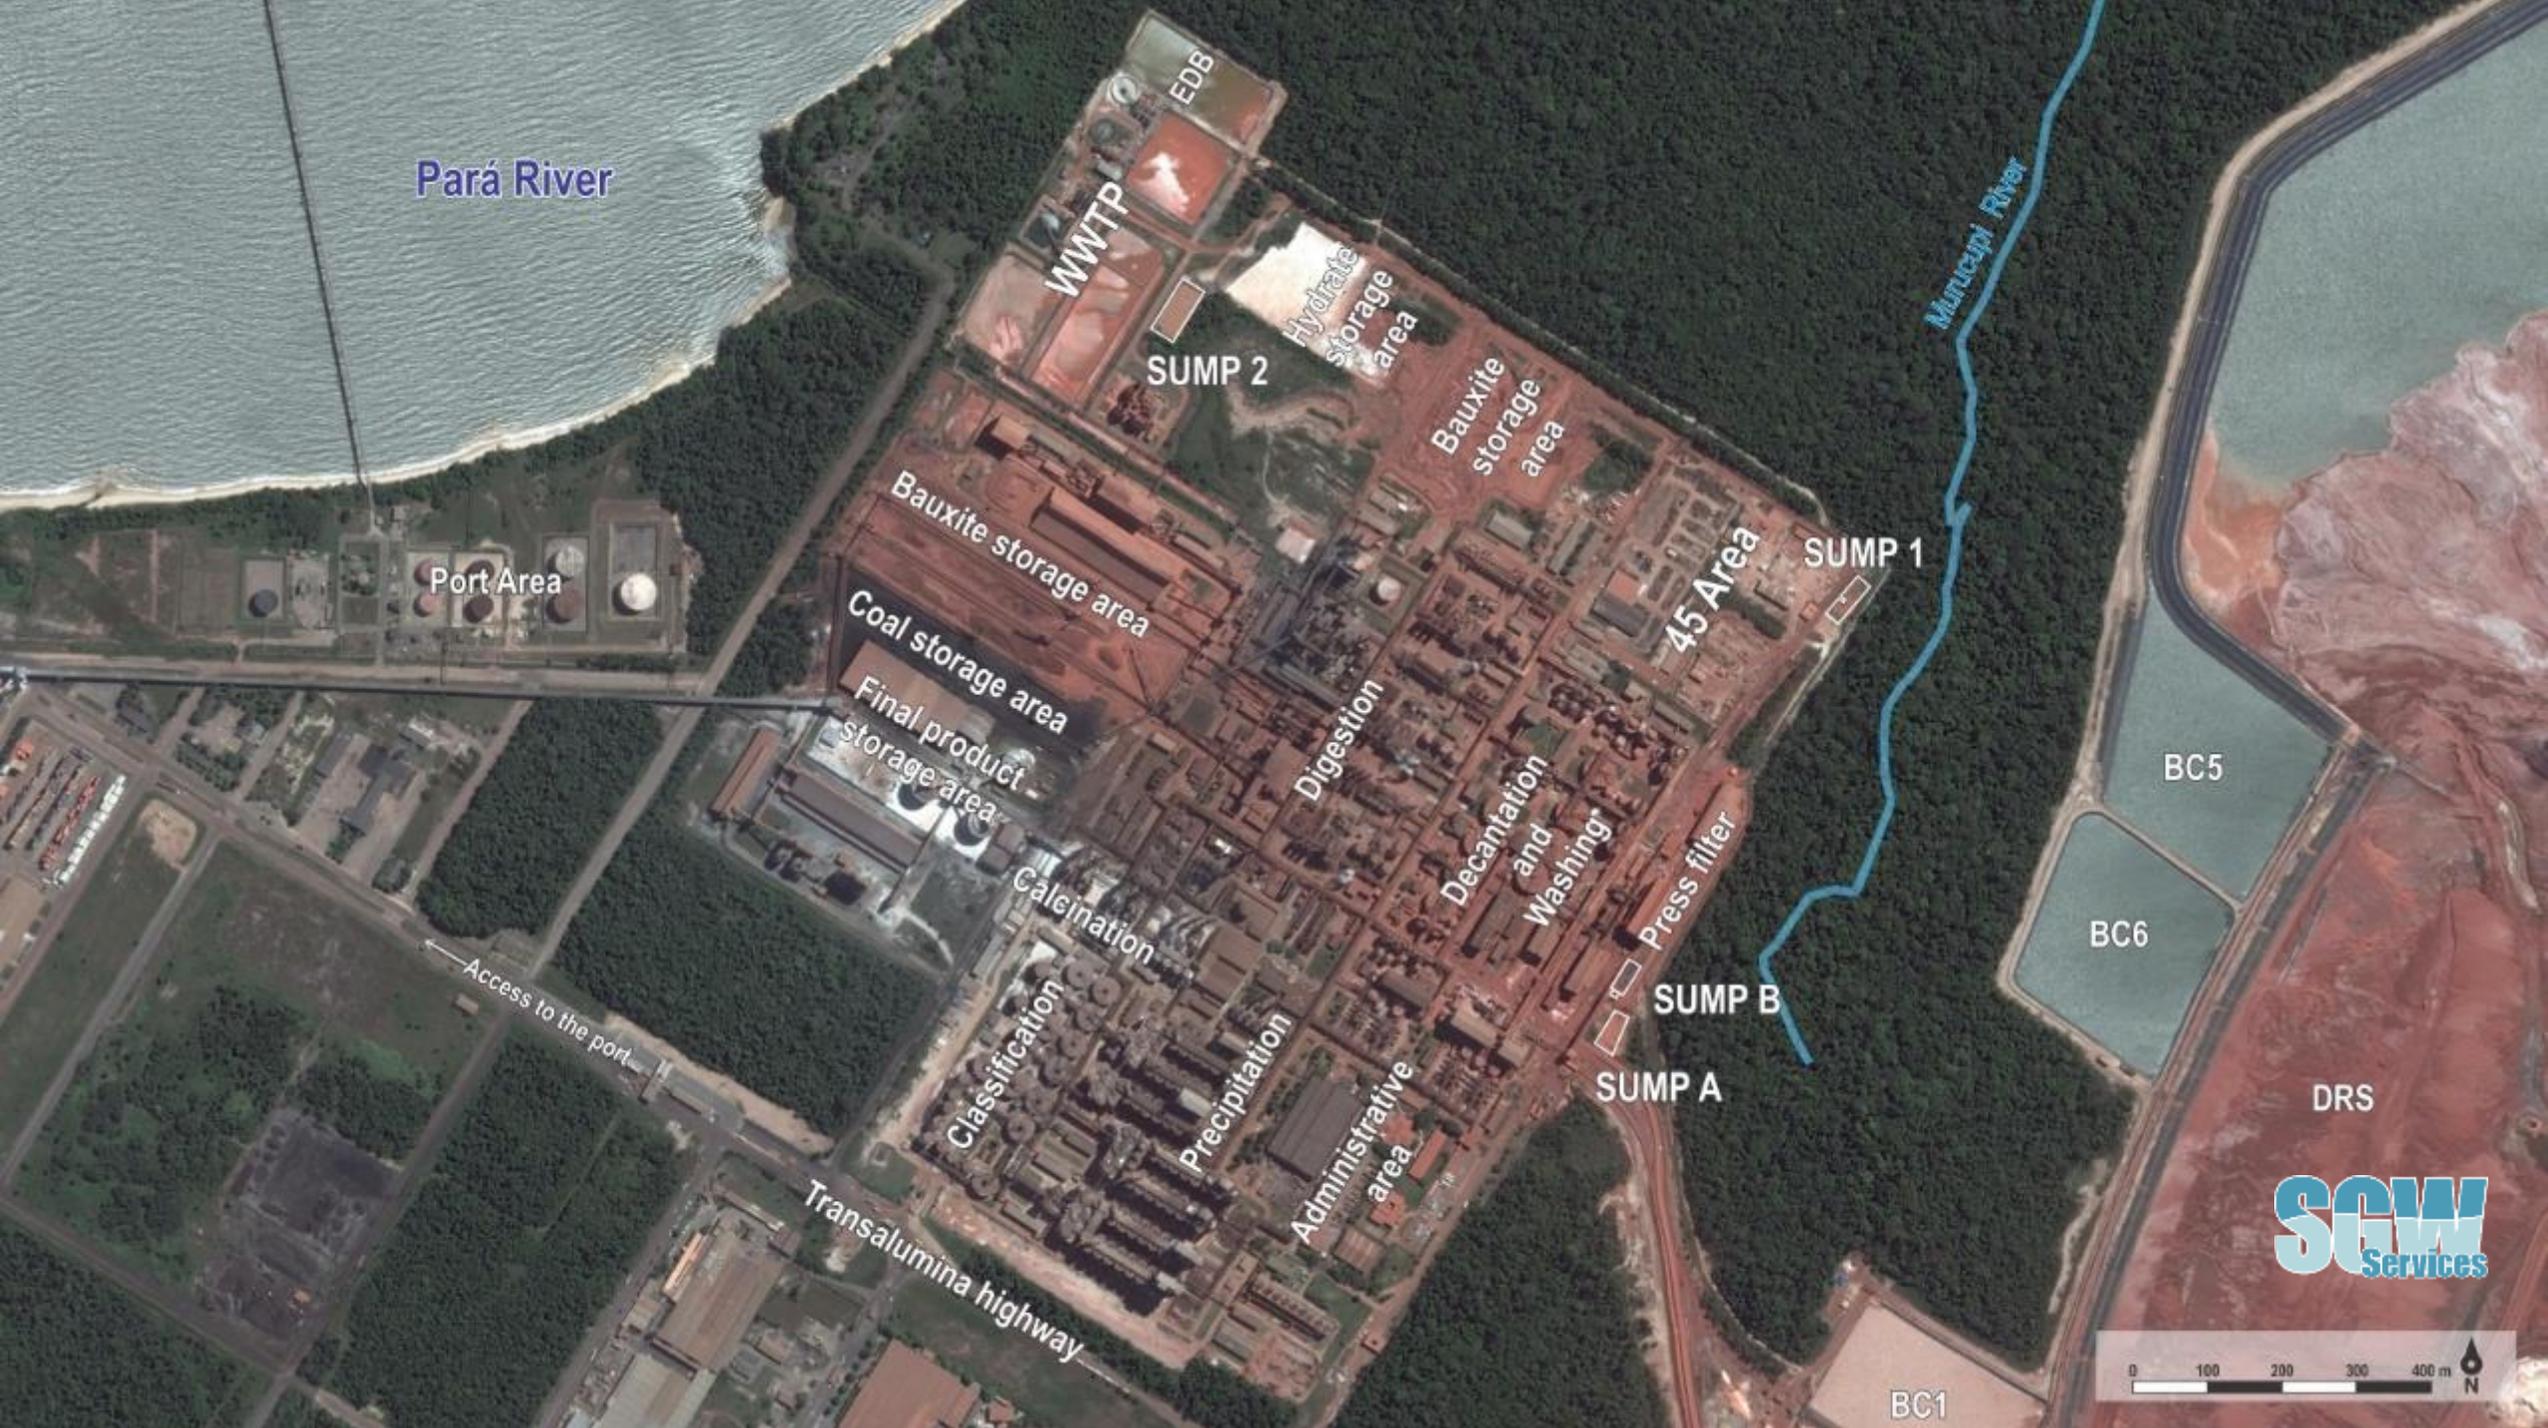
## 224mm rain in 10 hours

- ✓ There was no overflow at the solid waste basins - DRSs
- ✓ There was a Flood in Area 45 - The rainwater leakage occurred by a cracked deactivated pipe. Visual inspections and soil pH measurements results did not identify environmental alterations. **There was no overflow towards the Murucupi River. There are no evidences of environmental impacts in the river due to the deactivated pipe leakage.**
- ✓ Untreated rainwater was discharged into the **Pará River** by the *Canal Velho* in order to avoid WWTP basins overflowing. The discharge also received alkaline effluents from the process and there was a pH control and neutralization during this discharge.

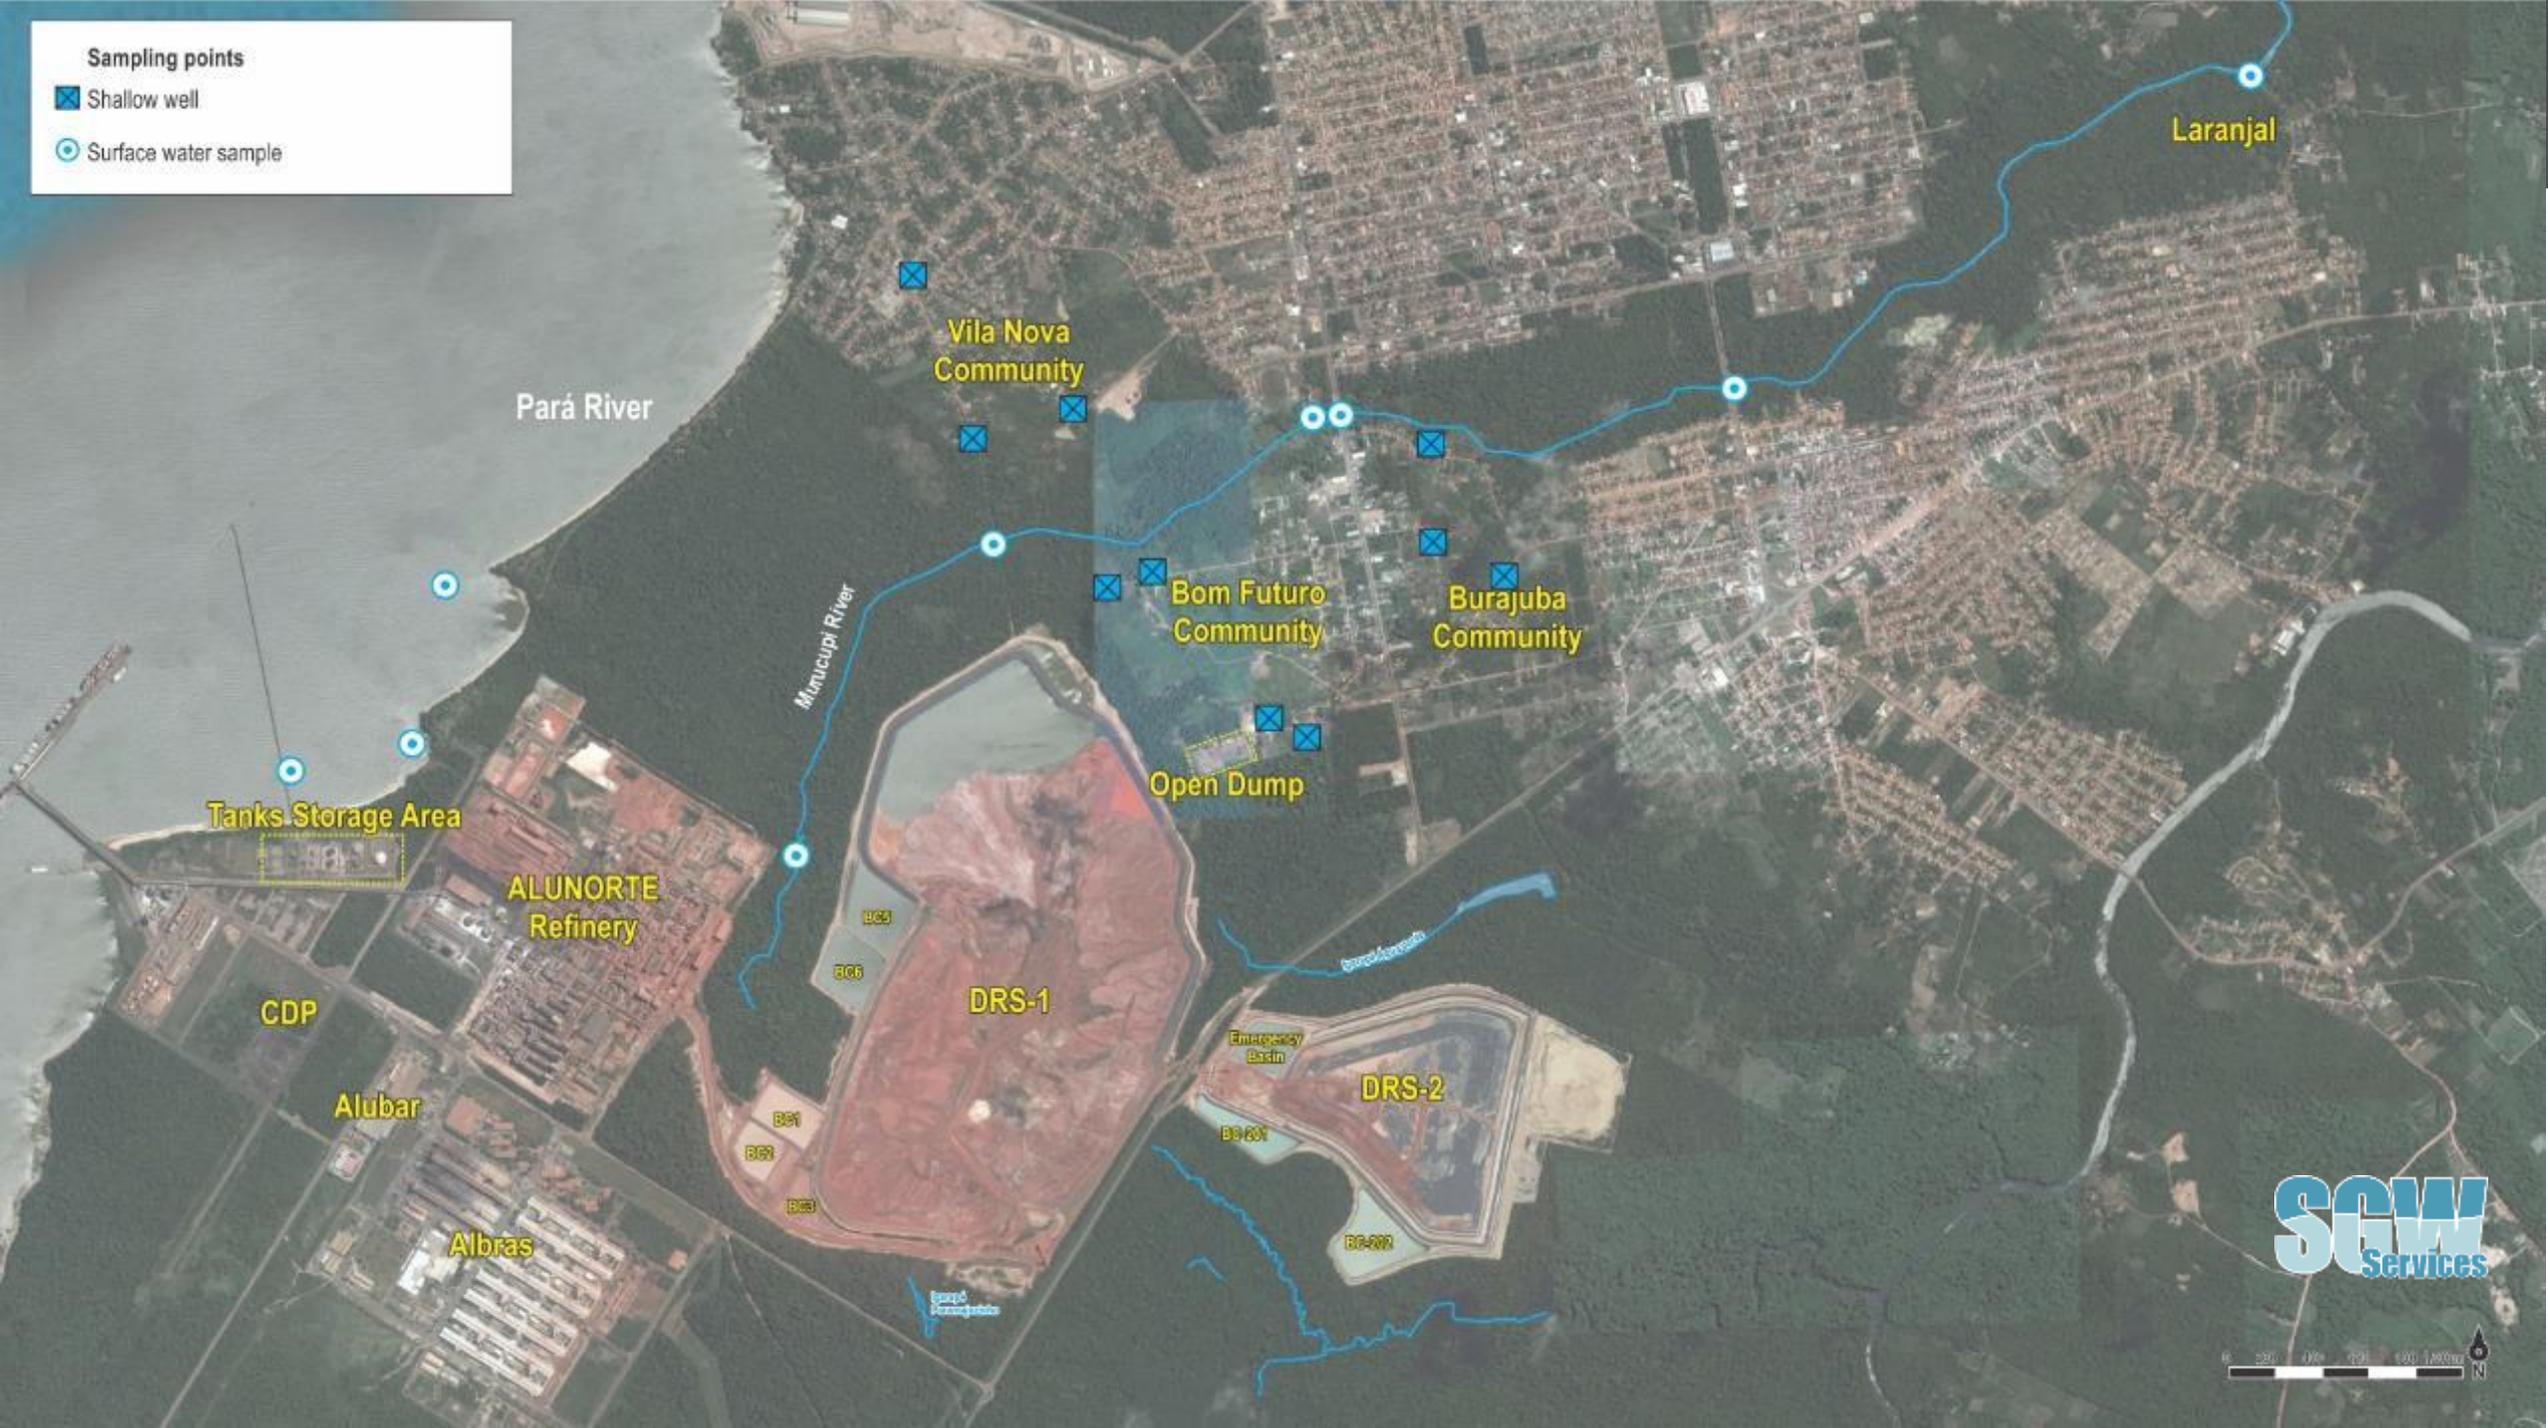
**Sampling points**

**Preliminary results indicate impact absence on water bodies and point to region's natural anomalies (Al and Fe)\***

**The metals results are n/d or below the legal levels in the community wells - except 1 spot (Al = 220 ppb - Standard 200 ppb).**
